Property Address: 111 Worthington Circle
New Market, AL 35761

Inspector: John Smith
Company: JS Lee III Enterprises LLC
dba WIN Home Inspection Madison
(256) 850-7030
jsmith@wini.com

Extended Home Inspection

Work Order Number: 14892504	Service date: 02/09/2012	Time: 09:00 AM
------------------------------------	---------------------------------	-----------------------

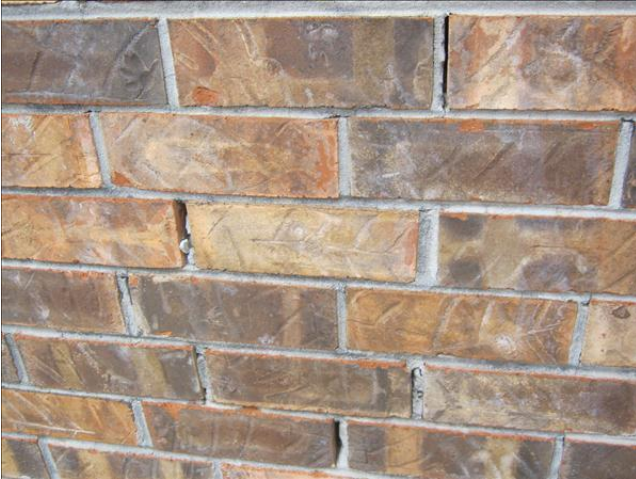
Figure 1

Inspector noticed places where mortar has cracked and deteriorated. Several spots are in need of touchup to ensure no water penetration. Recommend further evaluation and repair by a mason or handyman familiar with mason repairs.

Exterior Structure
Siding Condition
Maintenance
Mortar cracking or missing

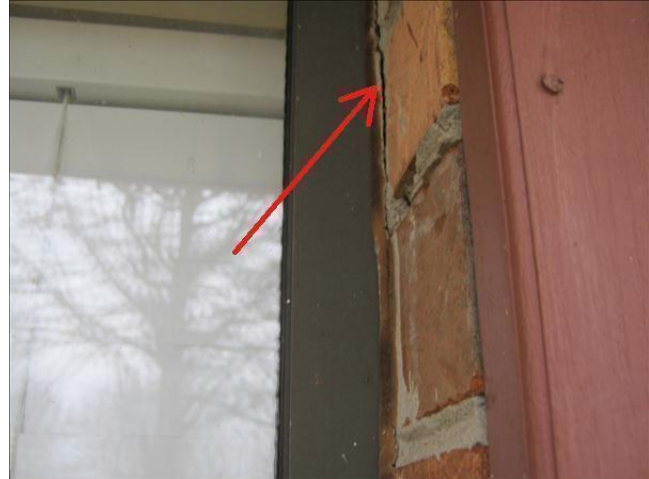
Figure 2

There is some structure caulking around exterior windows that needs attention and touch up in order to prevent damage, deterioration. Contact a qualified handyman for repairs. Be sure to use caulking rated for both brick and metal.

Exterior Structure
Caulking Structure
Maintenance
Caulking around windows missing or brittle

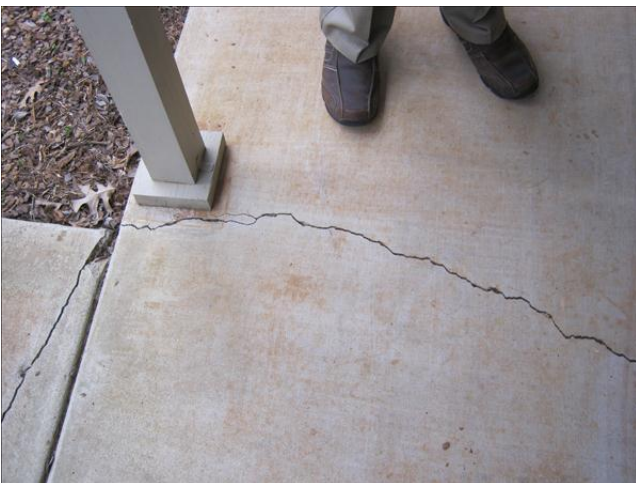
Figure 3

The driveway has several cracks but little to no apparent uplift. Inspector also noticed front walkway near main door has some cracking and minor uplift of less than one inch. This cracking represents a minor trip hazard, recommend surface repairs and monitoring cracks over time. The cracks can be repaired with a concrete rated caulking to prevent water penetration under the slab. If the cracks grow in size or continue to spread, contact a licensed contractor for further evaluation and repair estimates.

Site Concrete and Paving
Walkways
Maintenance
Cracking front door walkway

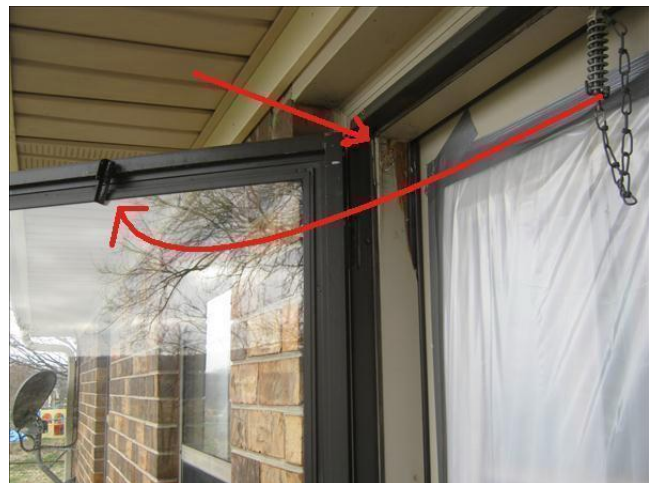
Figure 4

Inspector noticed rear screen door is damaged as is the door frame. The main rear door is also damaged and covered in plastic. It should be evaluated and repaired by a qualified door company.

Other Ext. Entry Doors
Storm/Screen Door(s)
Maintenance
Back door screen door.

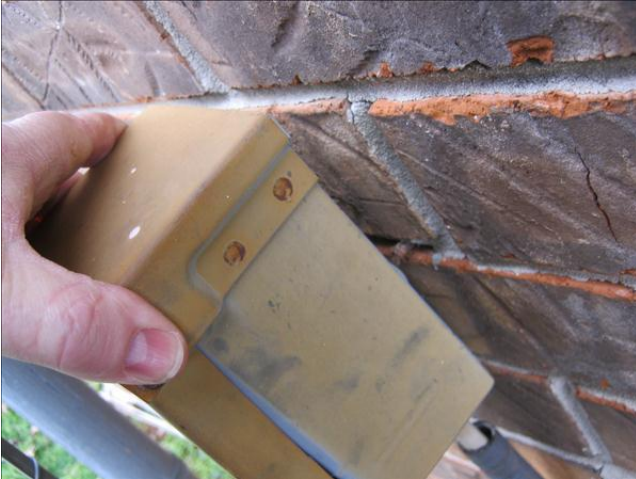
Figure 5

Electrical Service
Plugs, Switches, Junction Boxes, Lighting
Maintenance
Box on east wall needs to be mounted

Recommend an qualified electrician make all needed repairs.

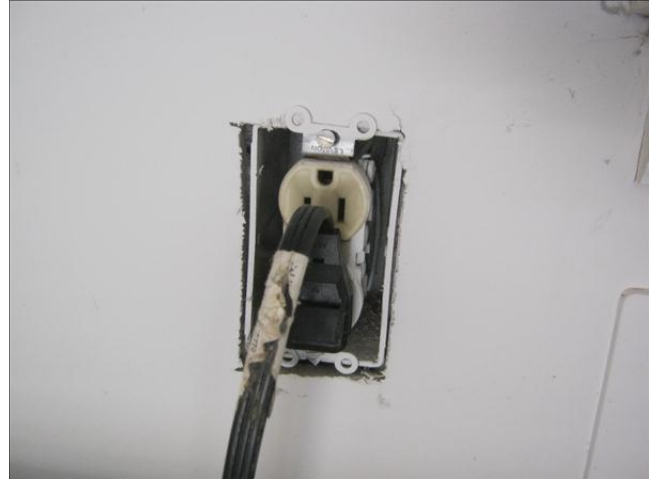
Figure 6

Electrical Service
Plugs, Switches, Junction Boxes, Lighting
Maintenance
Outlets need covers

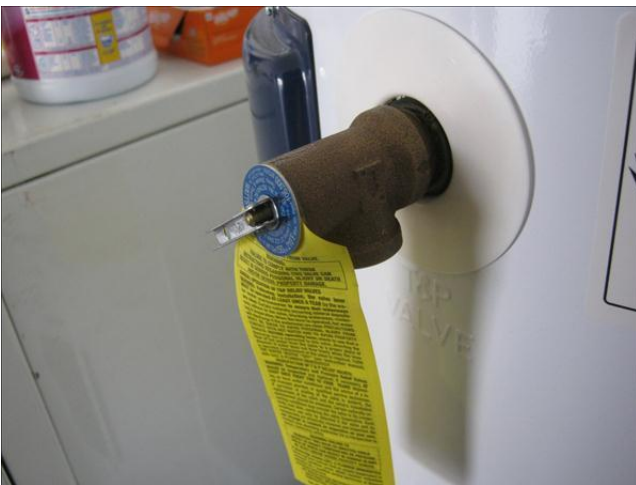
Figure 7

The overflow pipe connected to the pressure relief valve is missing. It should extend to approximately six to twelve inches above the floor or be run to the exterior of the home. Installing an approved pipe of the appropriate length is recommended to prevent accidental scalding in the event of an overheating situation. Some consideration may be given to re-routing the pipe to an appropriate location outside the garage/laundry area. Recommend further evaluation and repair by a qualified specialist or licensed plumber.

Water Heater
Discharge Pipe
Maintenance
Emergency pressure release

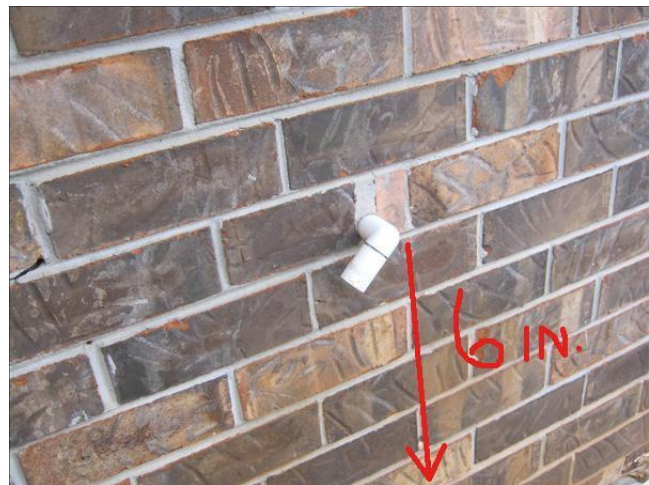
Figure 8

Water Heater
Discharge Pipe
Maintenance
Exterior drain pipe water heater extend to w/i 6 inches of ground

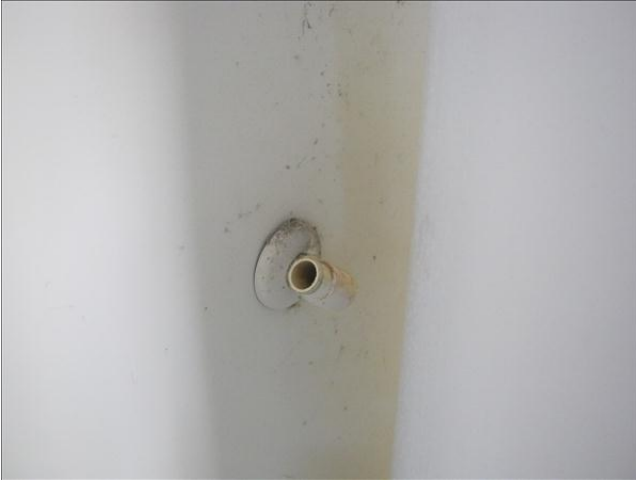
Figure 9

Water Heater
Discharge Pipe
Maintenance
Drain valve not connected
